Costa-Scorse, B. A., Hopkins, W. G., Bahr, R. (2015). Evaluation of ski-binding-boot system safety using torque testing. *ASTM Special Technical Publication, STP 1582*, 163-170.

Evaluation of Ski-Binding-Boot System Safety Using Torque Testing

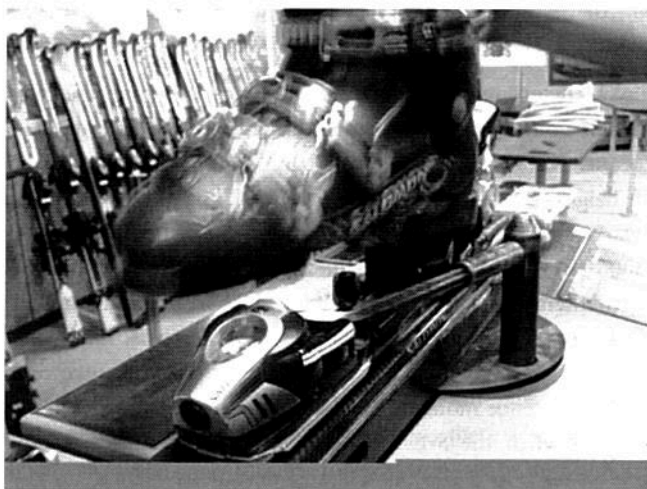
FIG. 1 Wintersteiger calibration machine torque testing the toe-piece in Mz twist.
